THE FEASIBILITY OF BURNER-CAN BURN-
THROUGH THERMAL DETECTION PRIOR TO
ENGINE CASE RUPTURE

14
Report No. **FAA-RD-72-134**

Richard Hill
National Aviation Facilities Experimental Center
Atlantic City, New Jersey 08405

FINAL REPORT

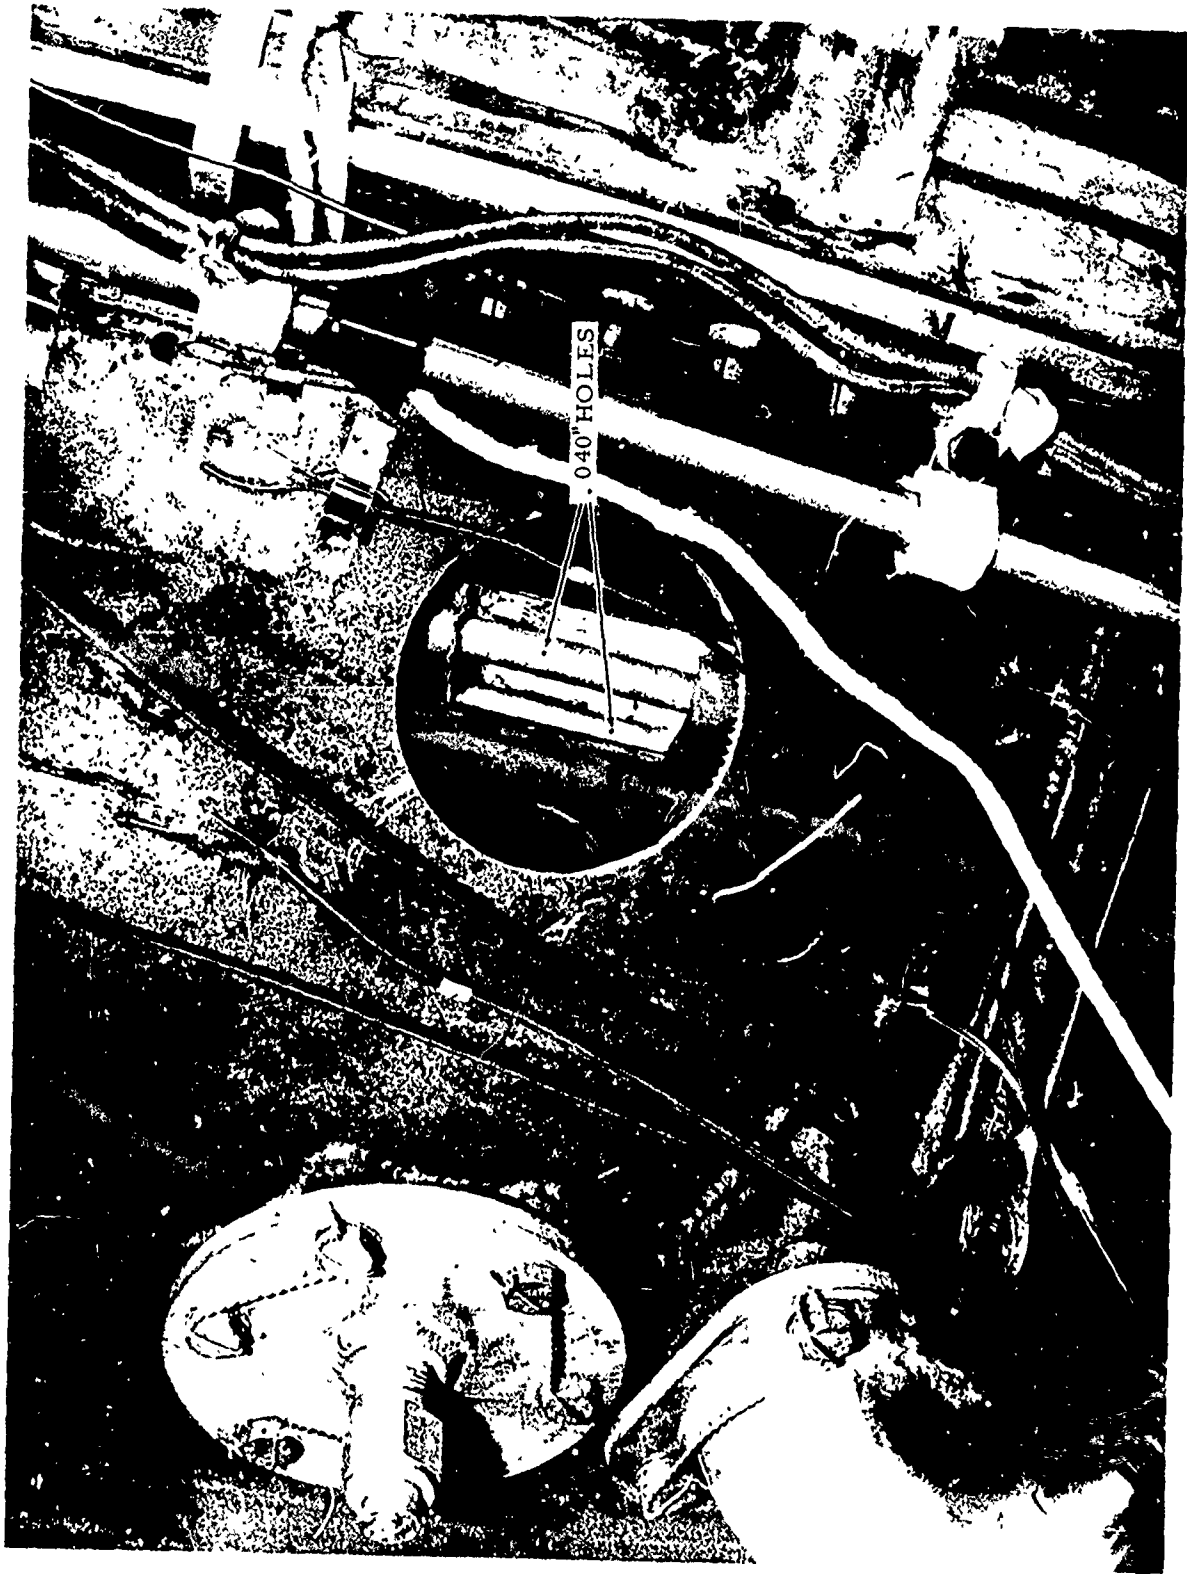
FIGURE 2. HOLES IN J57 INTERNAL FUEL MANIFOLD

In order to cause a burn-through failure in the J57 test engine, a hole was cut in the diffuser case allowing access to the internal fuel manifold. A section of the stainless steel protective shroud around the fuel lines was removed. A 0.040-inch hole was drilled in both the primary and secondary fuel lines (Figure 2). The hole in the diffuser case was then repaired by rewelding the removed piece of material in place.

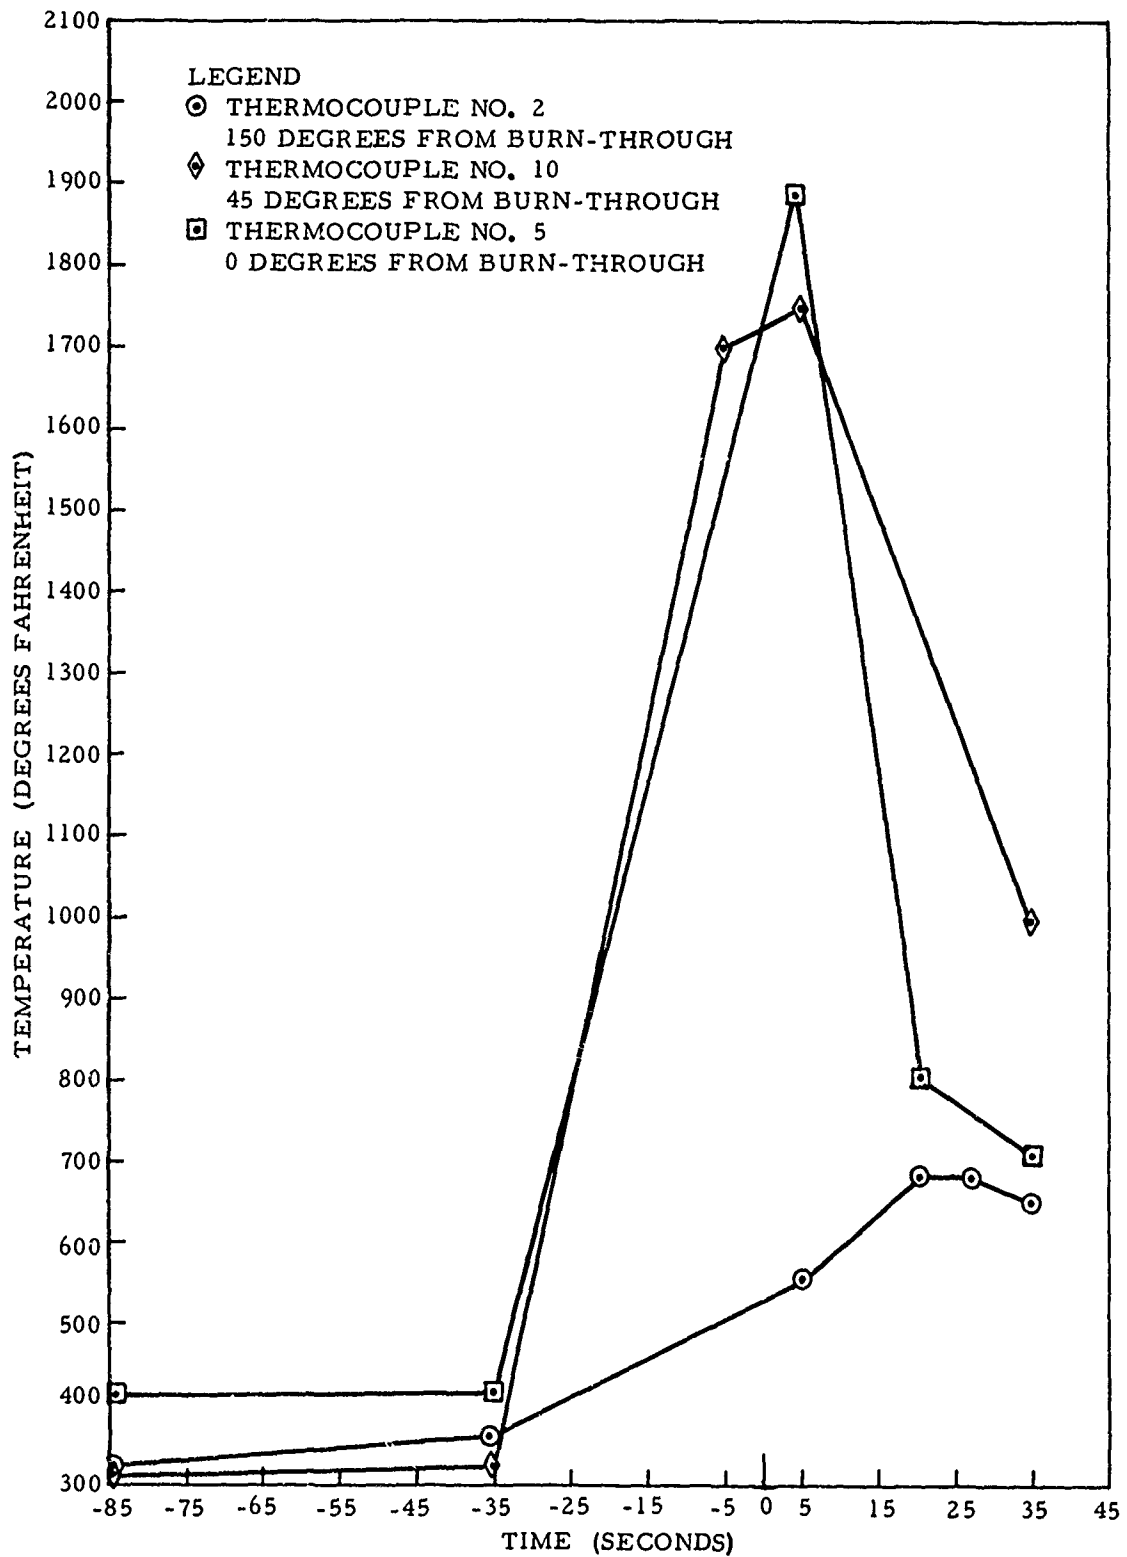
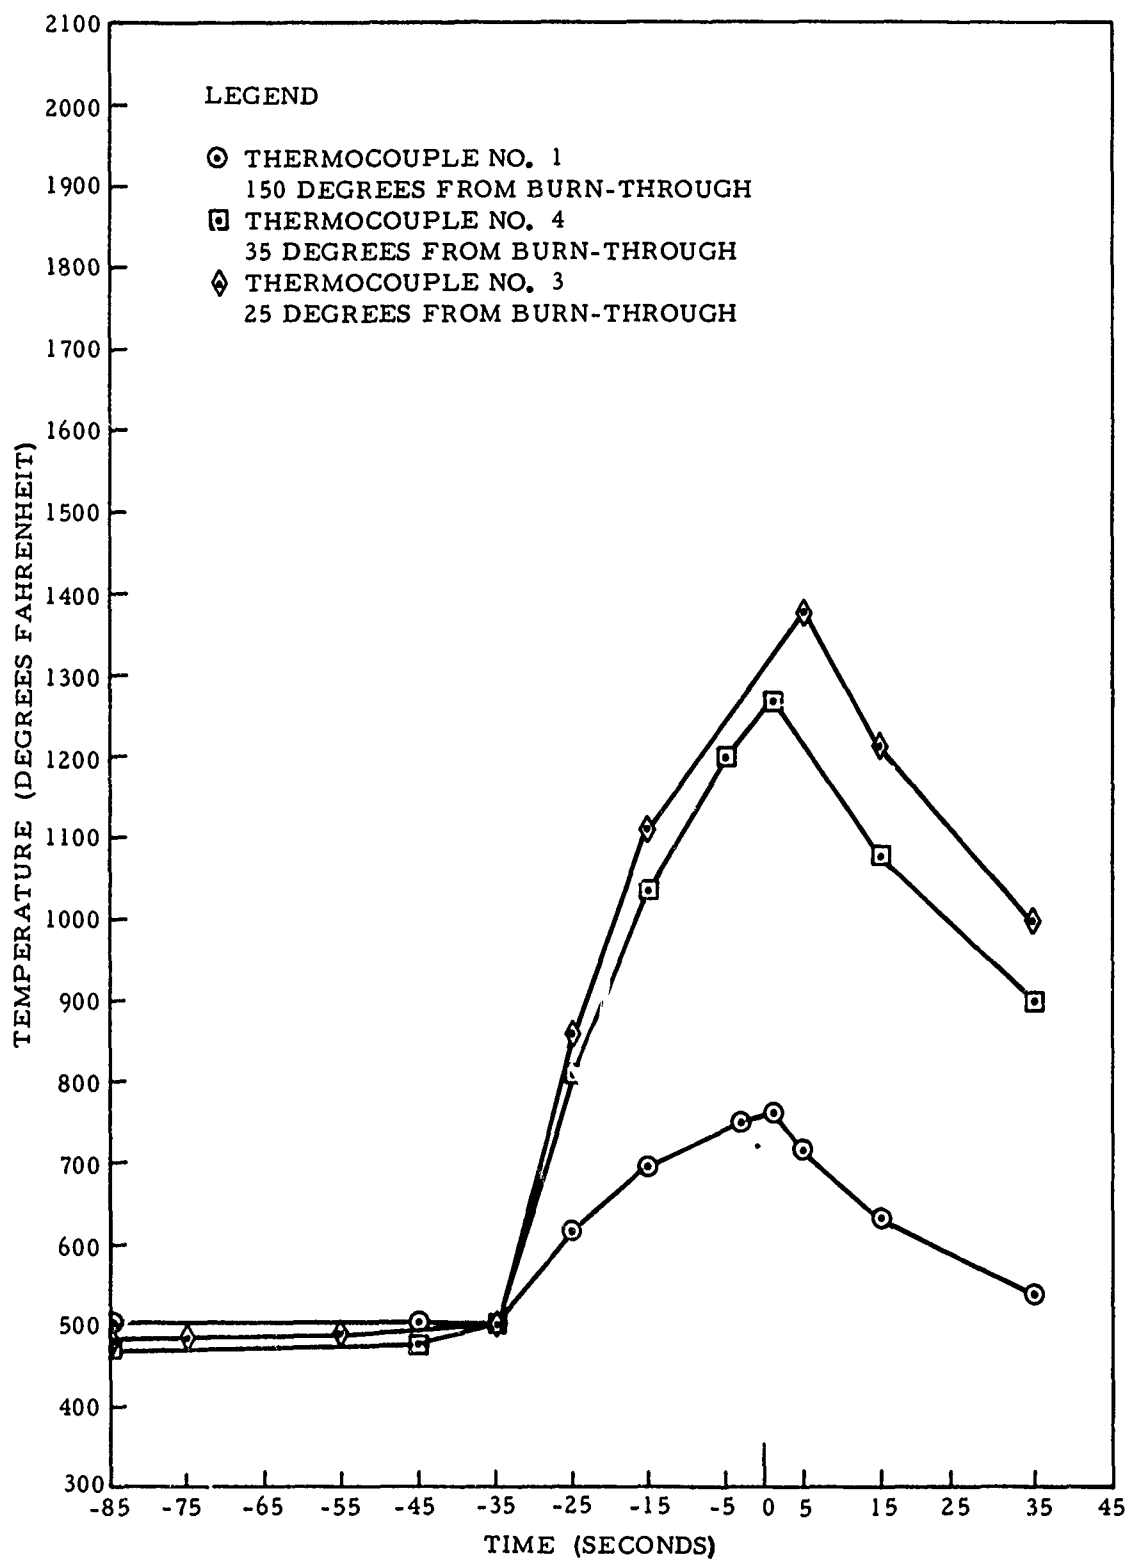
Test No. 1. Figures 17 and 18 show the temperature profile of selected thermocouples on the diffuser case and the burner can case prior to, during and after a burn-through. The thermocouples in the general proximity (within 45°) showed a rapid and large increase in temperature beginning 40 seconds prior to burn-through. The thermocouples located approximately 150° around the engine from the burn-through also showed an increase in skin temperature, but of a much lower magnitude.

FIGURE 17. DIFFUSER CASE TEMPERATURES DURING TEST NO. 1

FIGURE 18. BURNER CAN CASE TEMPERATURES DURING TEST NO. 1

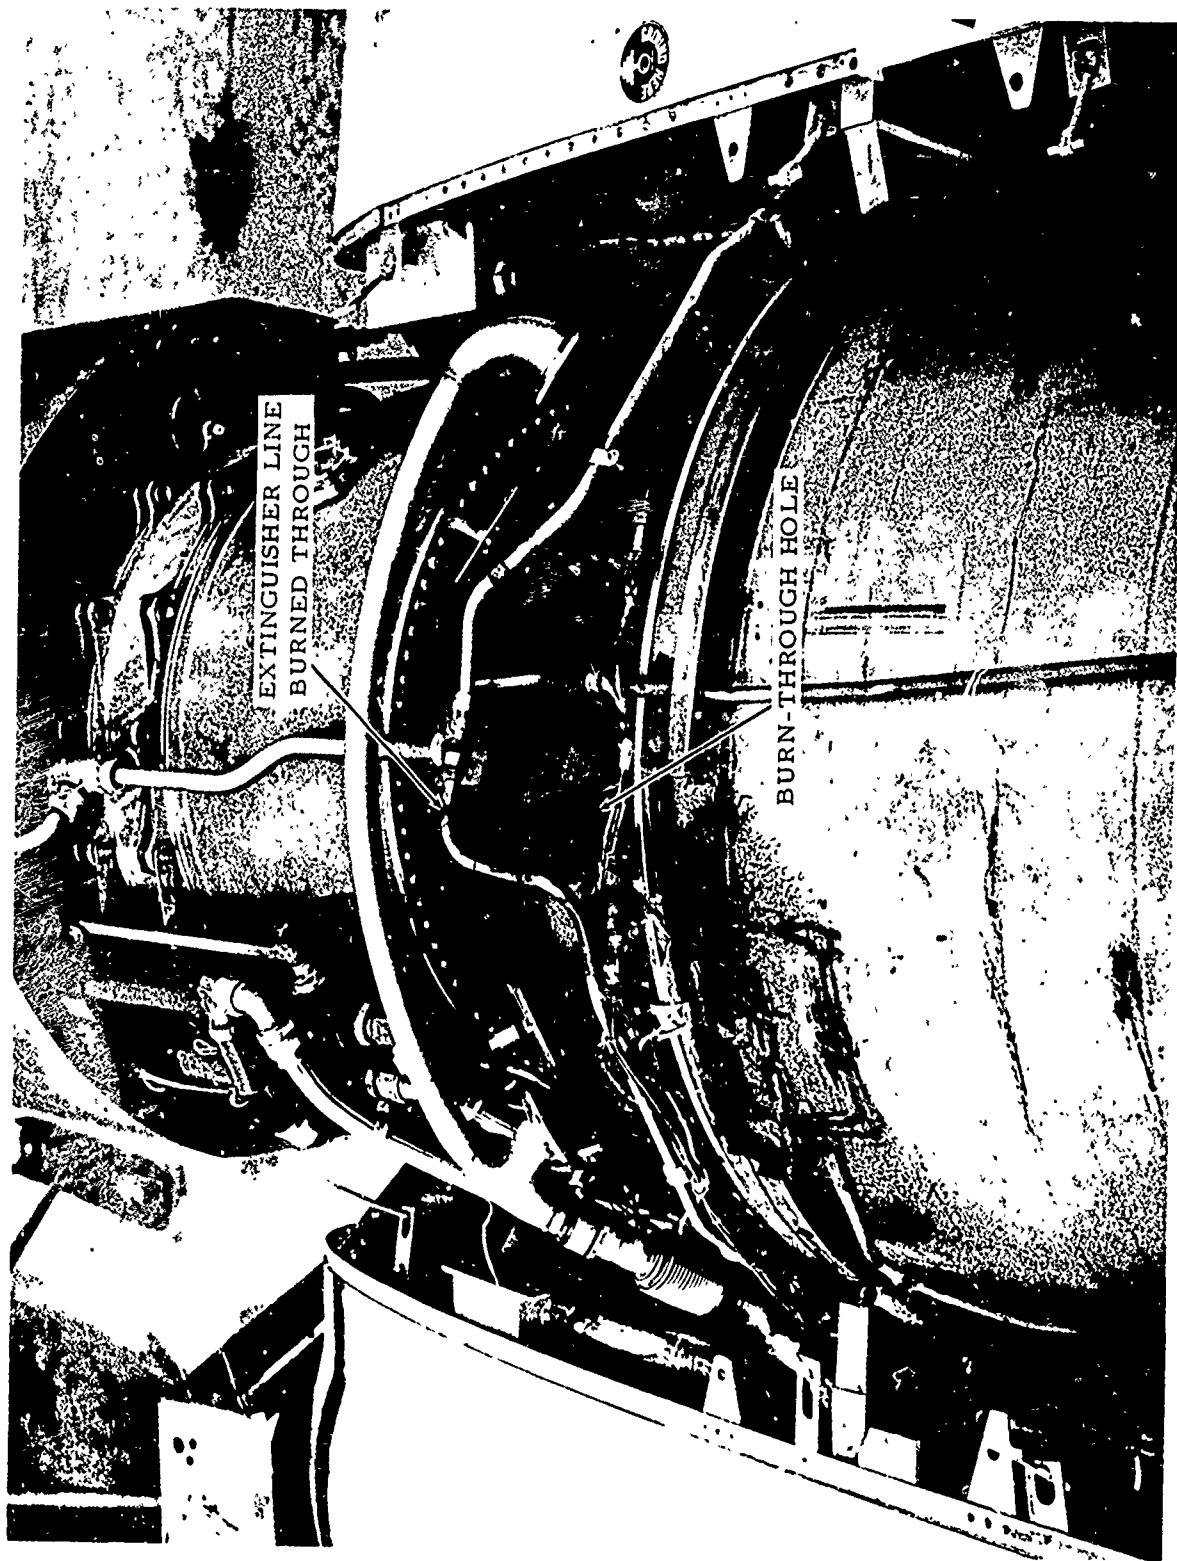
Figures 19 and 20 show the damage, from this burn-through, to the diffuser case. The size of the hole was approximately 3 X 4 inches. (Note the holes in the stainless steel fire extinguisher discharge line.) Burn-through time for the 0.030-wall tubing was approximately 1 second.

FIGURE 19. J57 BURN-THROUGH DAMAGE, TOP VIEW

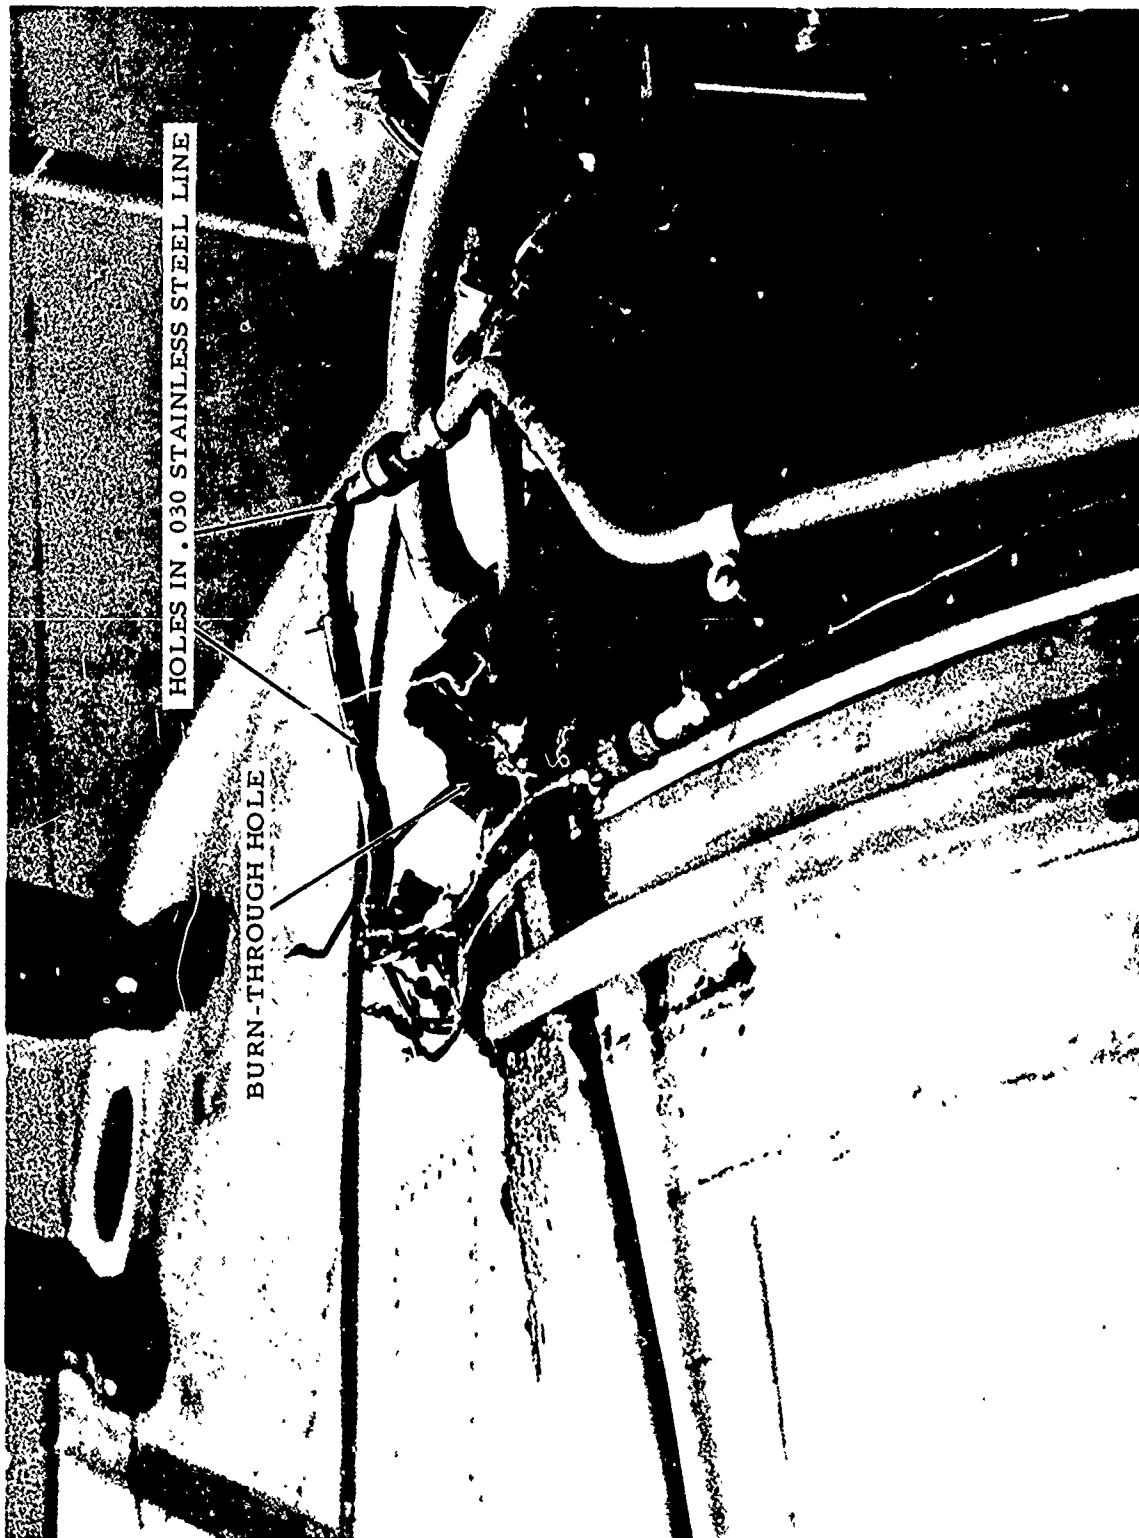
FIGURE 20. J57 BURN-THROUGH DAMAGE, SIDE VIEW

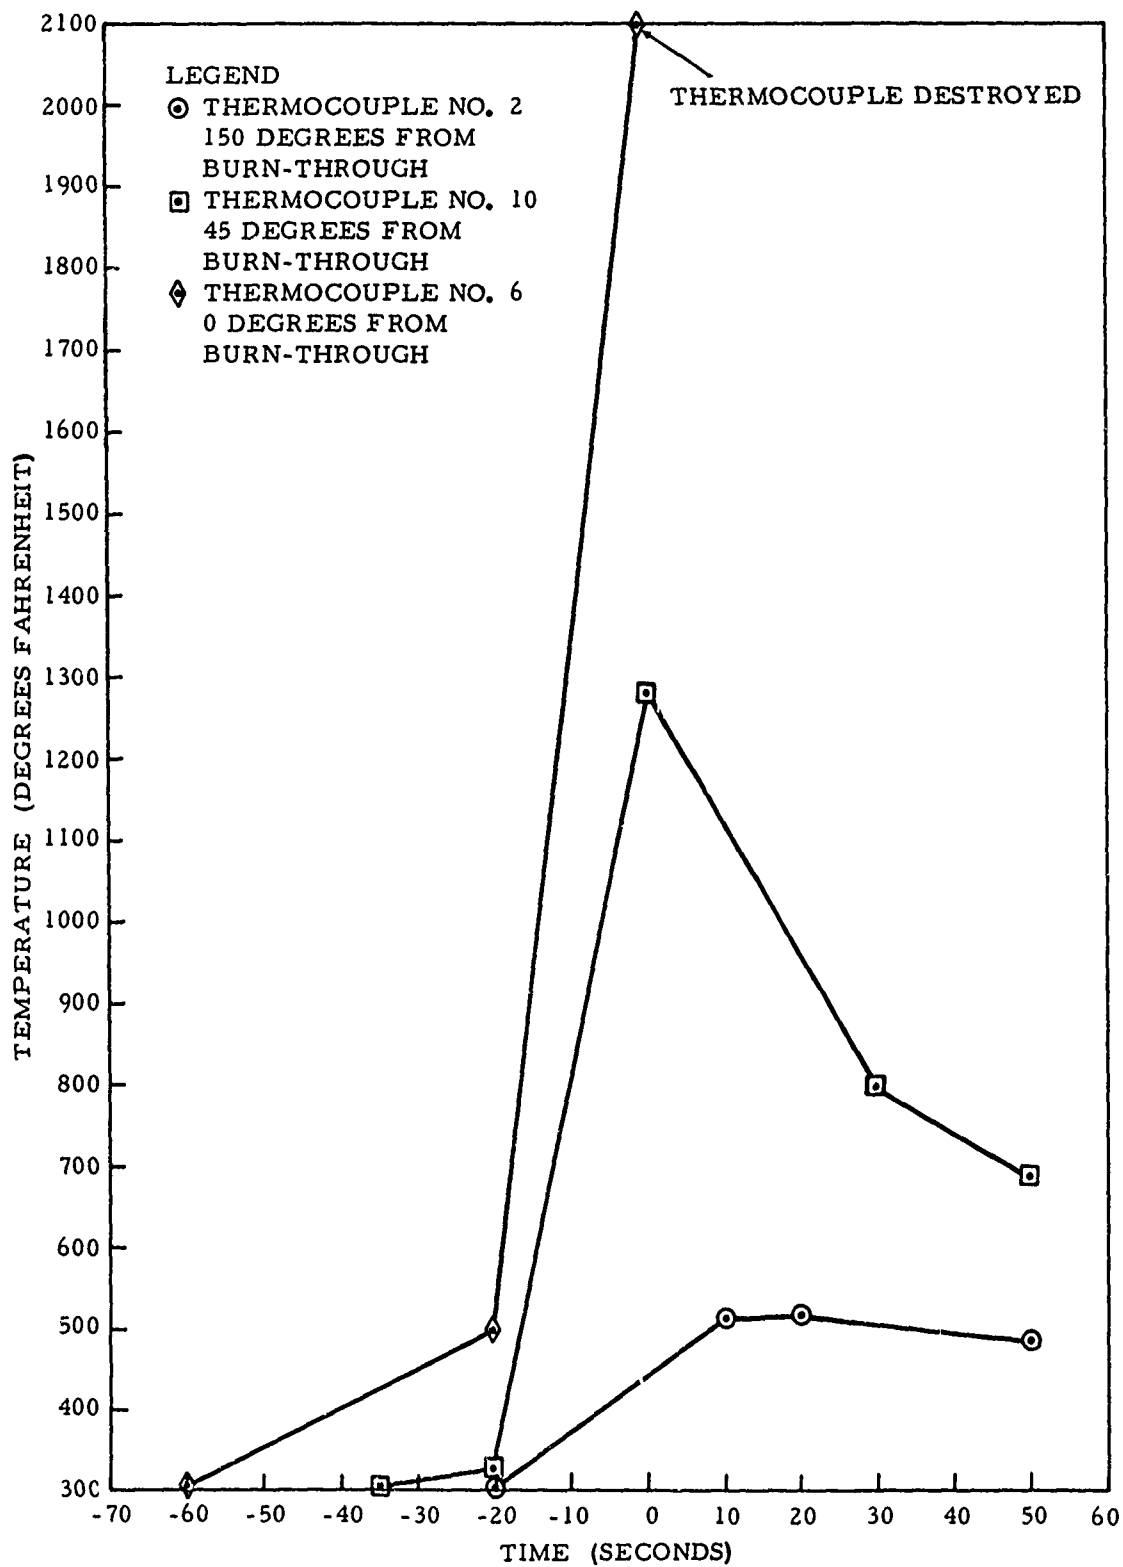
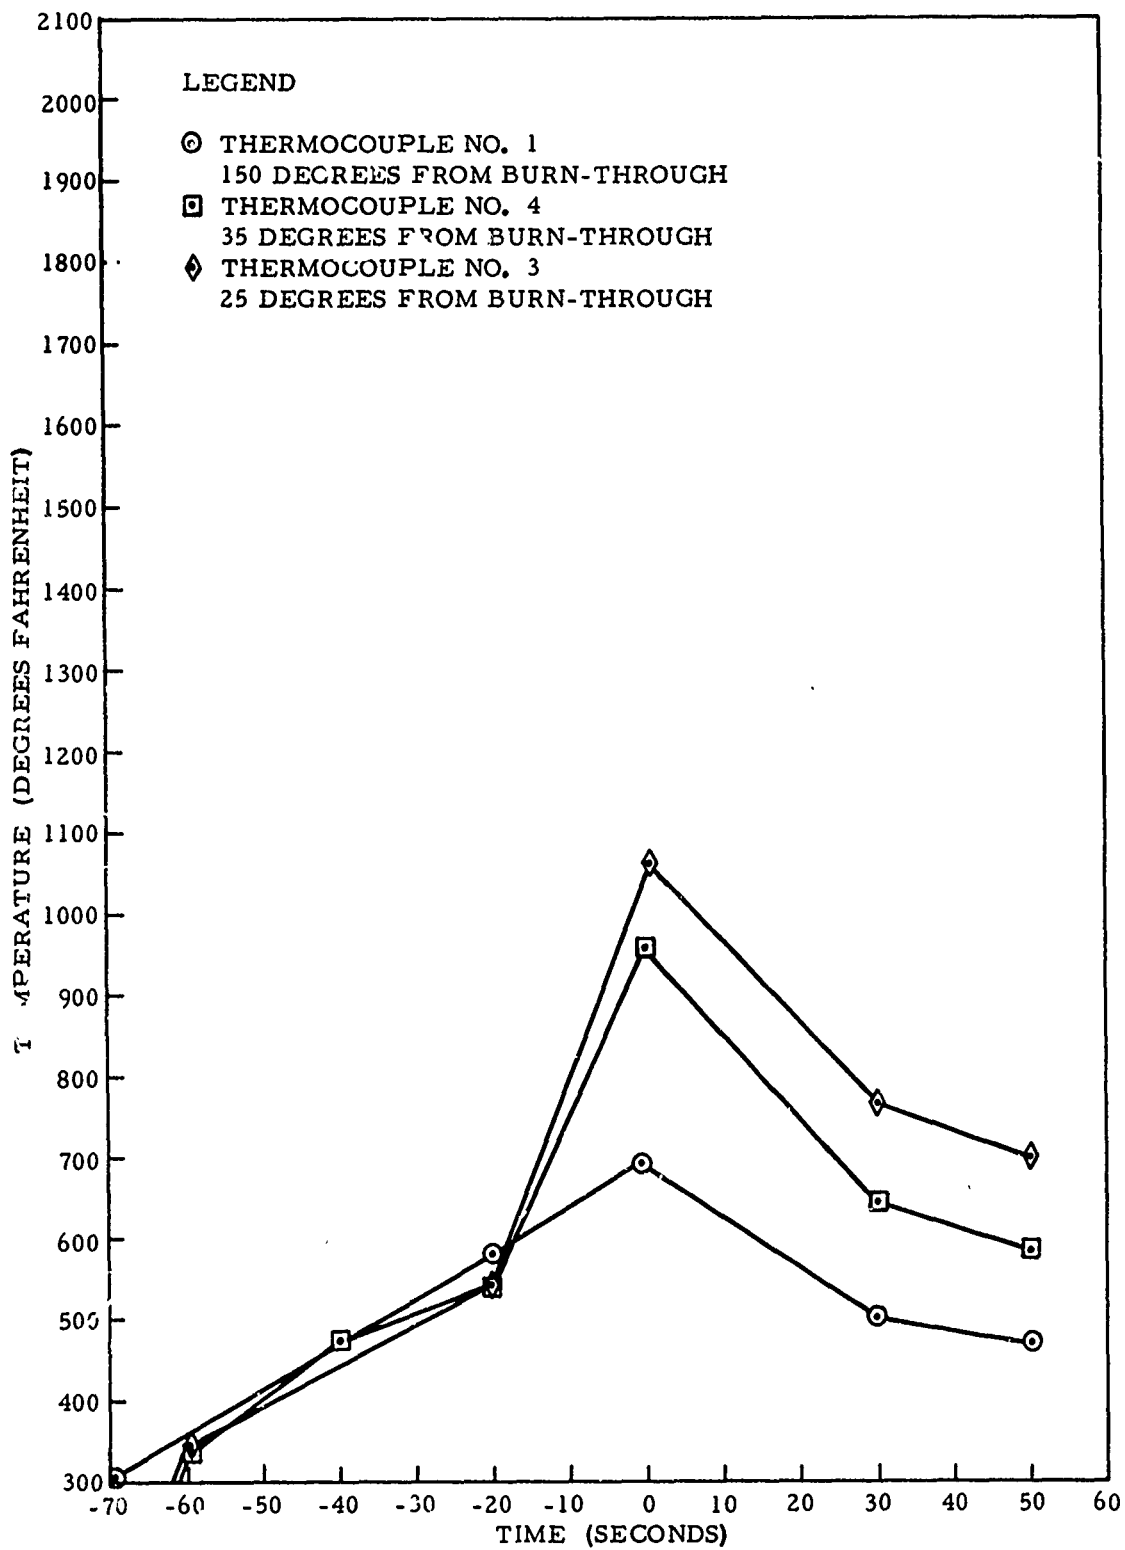
Test No. 2. The results of Test No. 2 can be seen in Figures 21 and 22 and the resultant damage from the burn-through in Figure 23. The burn-through hole in Test No. 2 was slightly larger than that in Test No. 1. The results of the test was similar to the first test, except the magnitude of the temperatures was not as high. This could have been caused by an earlier rupture of the diffuser case due to its weakened condition.

FIGURE 21. DIFFUSER CASE TEMPERATURES DURING TEST NO. 2

FIGURE 22. BURNER CAN CASE TEMPERATURES DURING TEST NO. 2

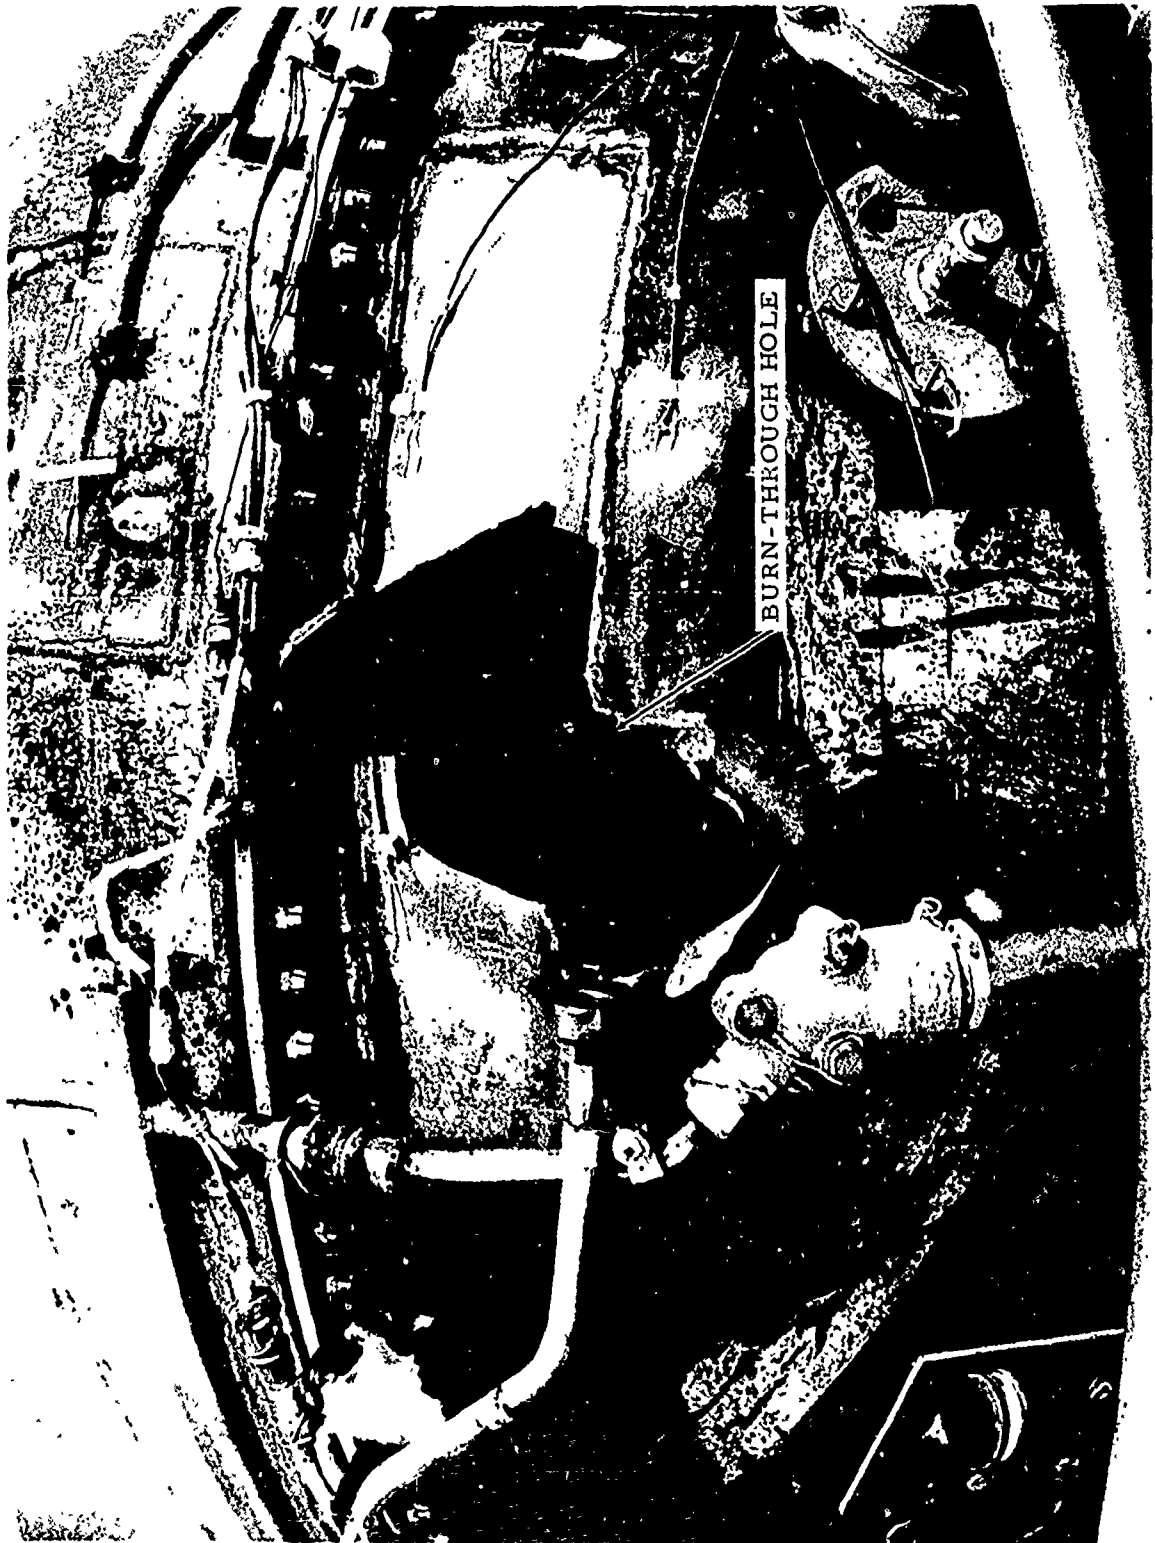
FIGURE 23. TEST NO. 2 BURN-THROUGH DAMAGE

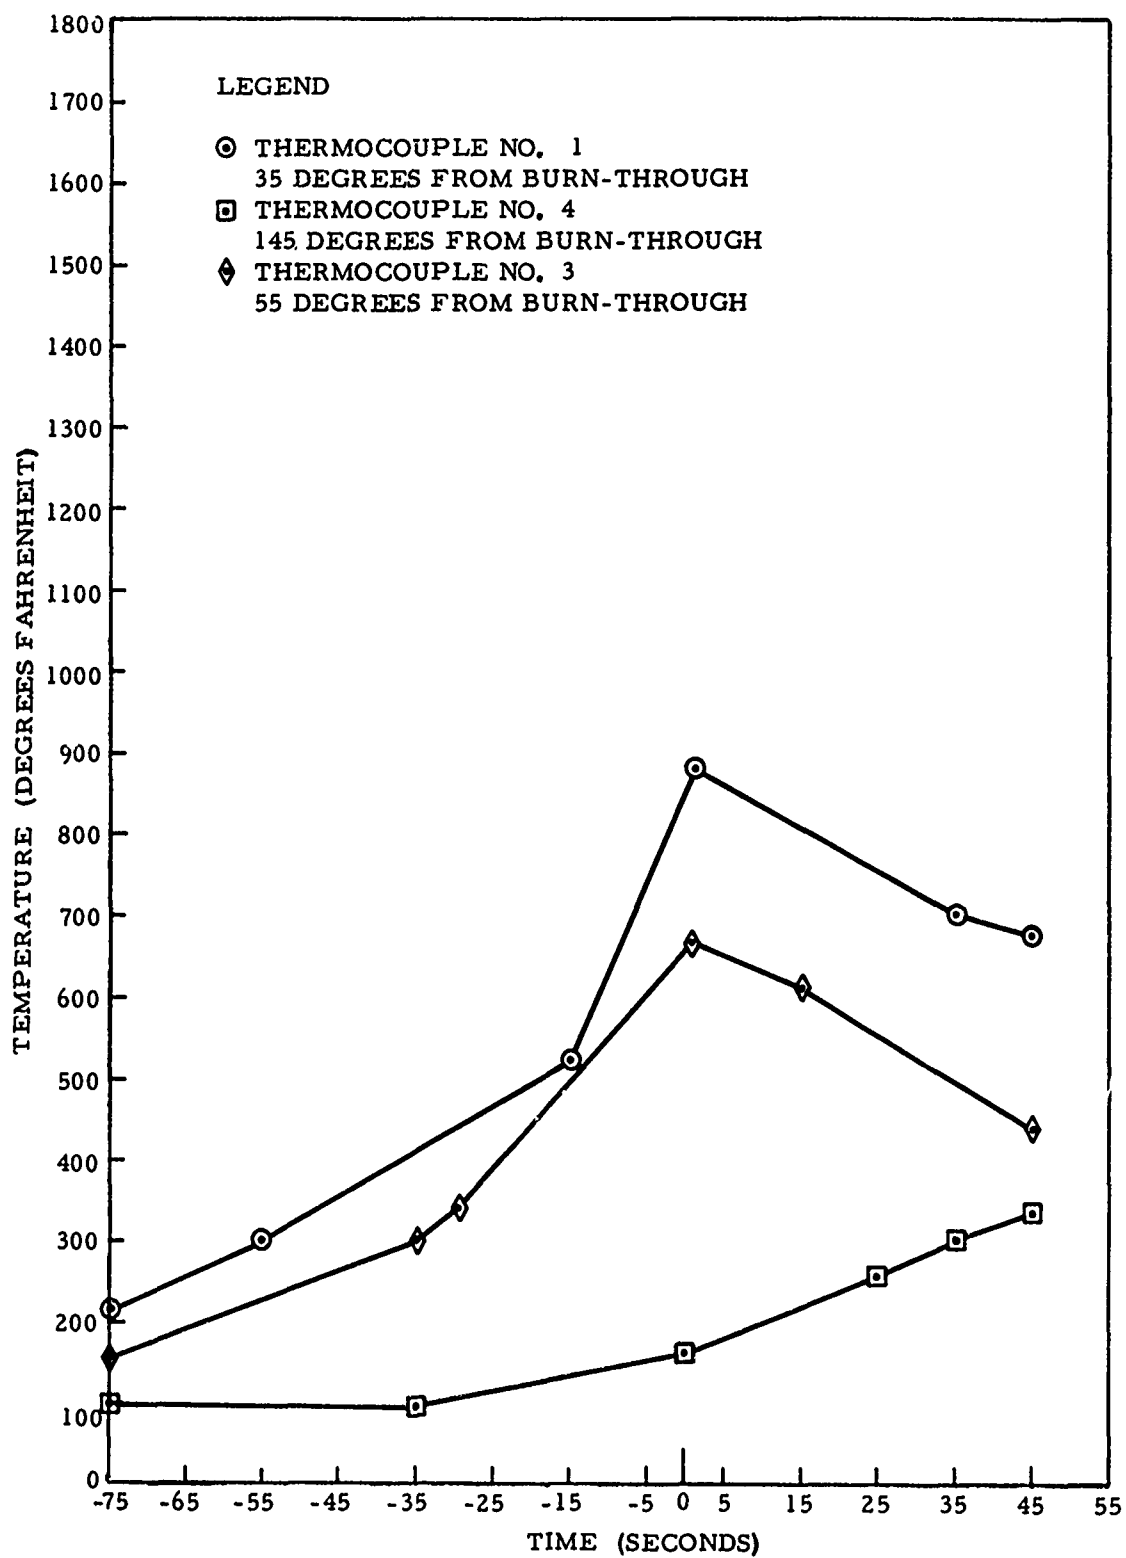
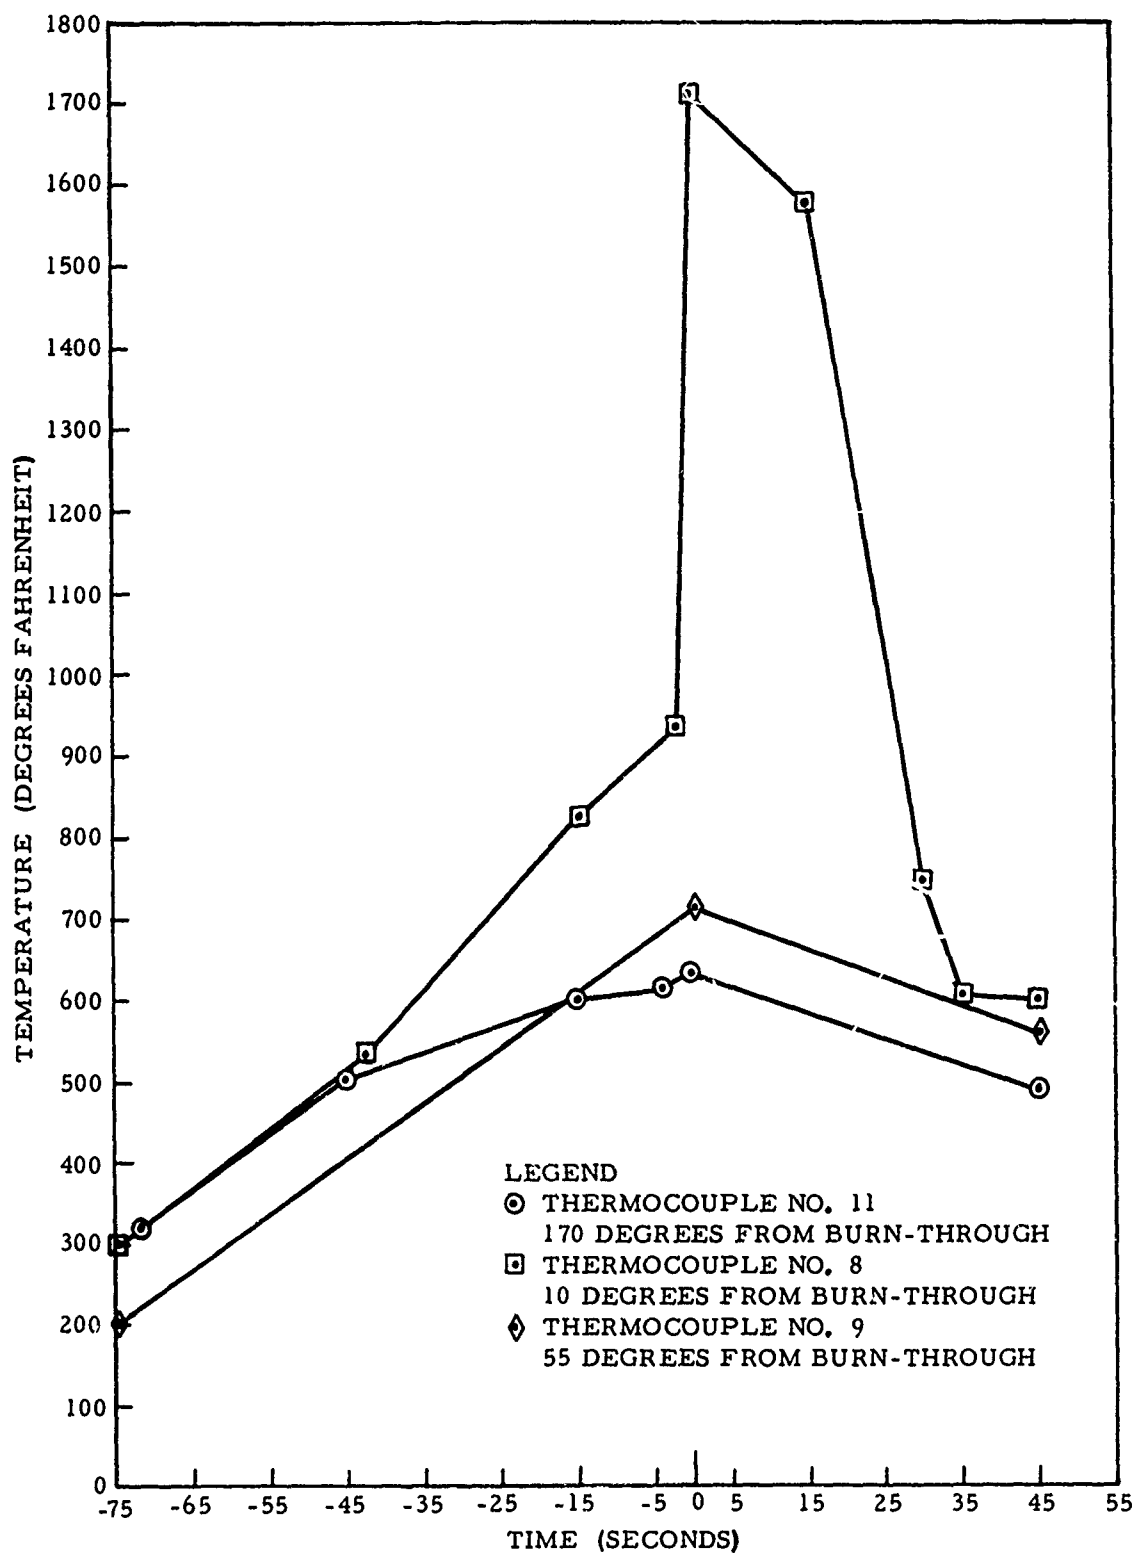
Test No. 3. The results of this fully-cowled-engine test is shown in Figures 24 and 25. Figures 26 through 28 show the damage caused by the burn-through. Unlike the prior two tests, the burn-through occurred in the burner can case an inch or so aft of the split line. A smaller secondary burn-through did occur just forward of the split line in the diffuser case. As a result of the location of the burn-through, the burner can case showed a much higher peak temperature than the diffuser case, whereas, the diffuser case still showed a much larger area of temperature rise.

FIGURE 24. DIFFUSER CASE TEMPERATURES DURING TEST NO. 3

FIGURE 25. BURNER CAN CASE TEMPERATURES DURING TEST NO. 3

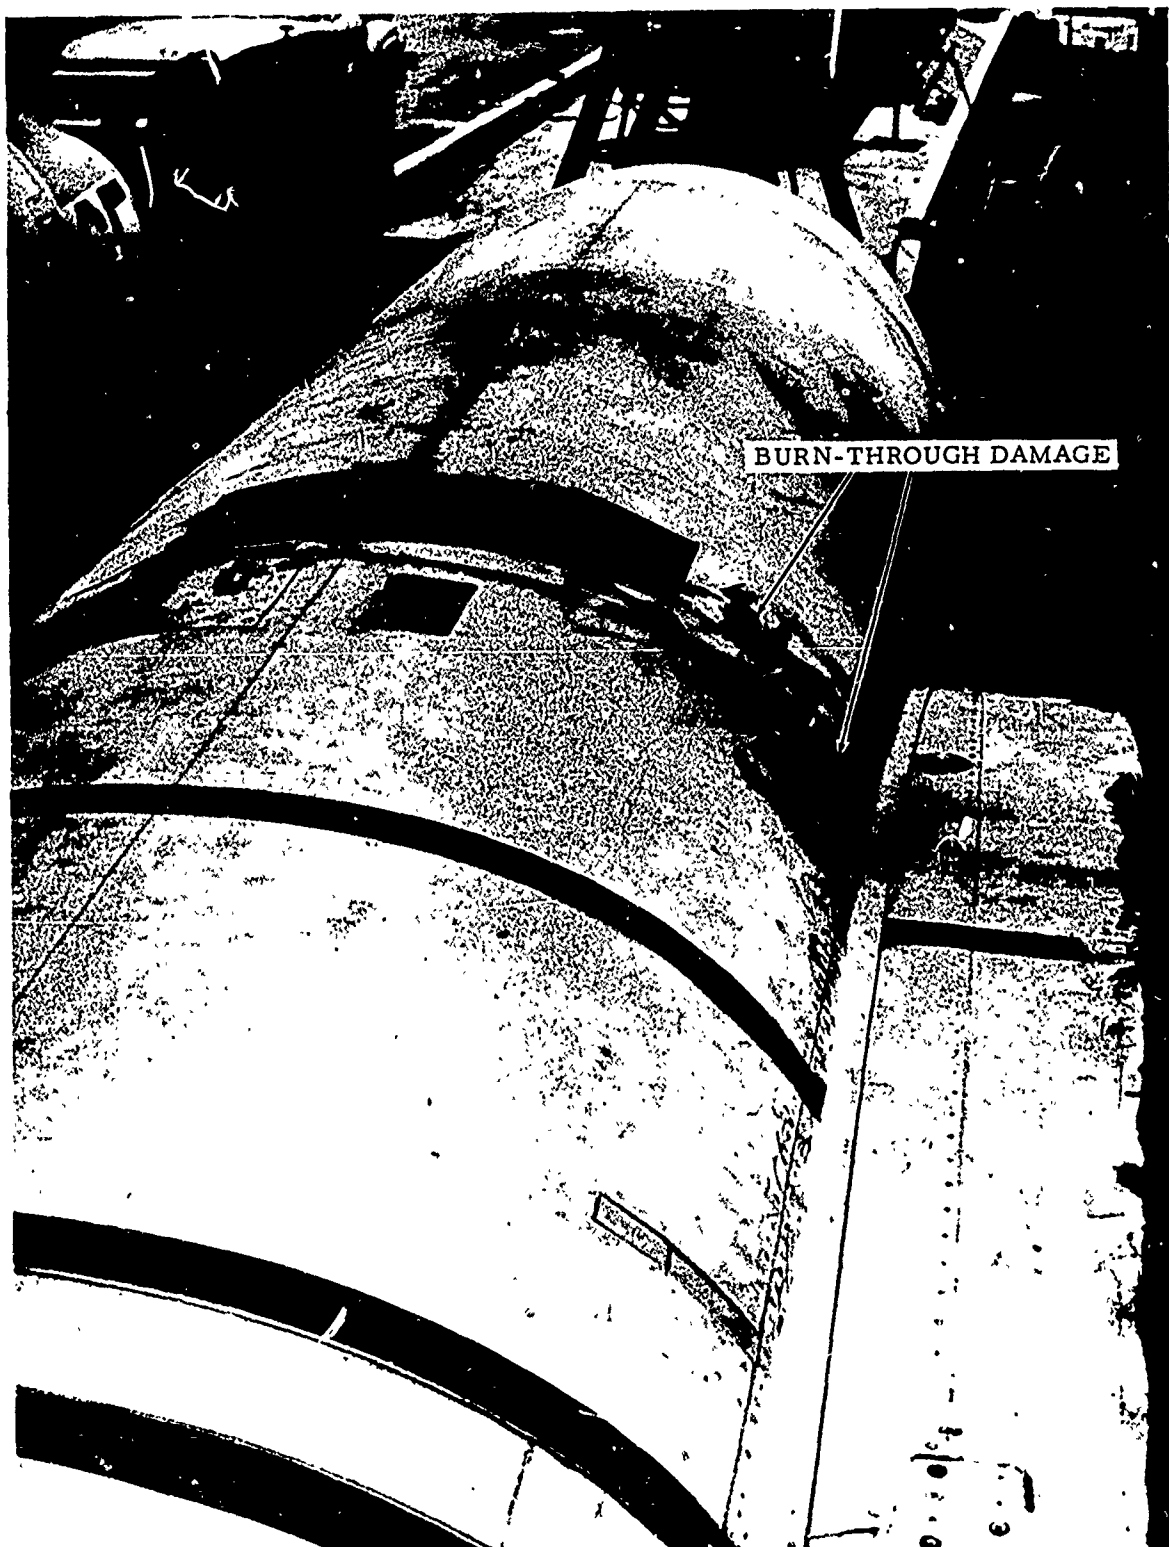
FIGURE 26. DAMAGE TO COWLING FROM BURN-THROUGH (TEST NO. 3)

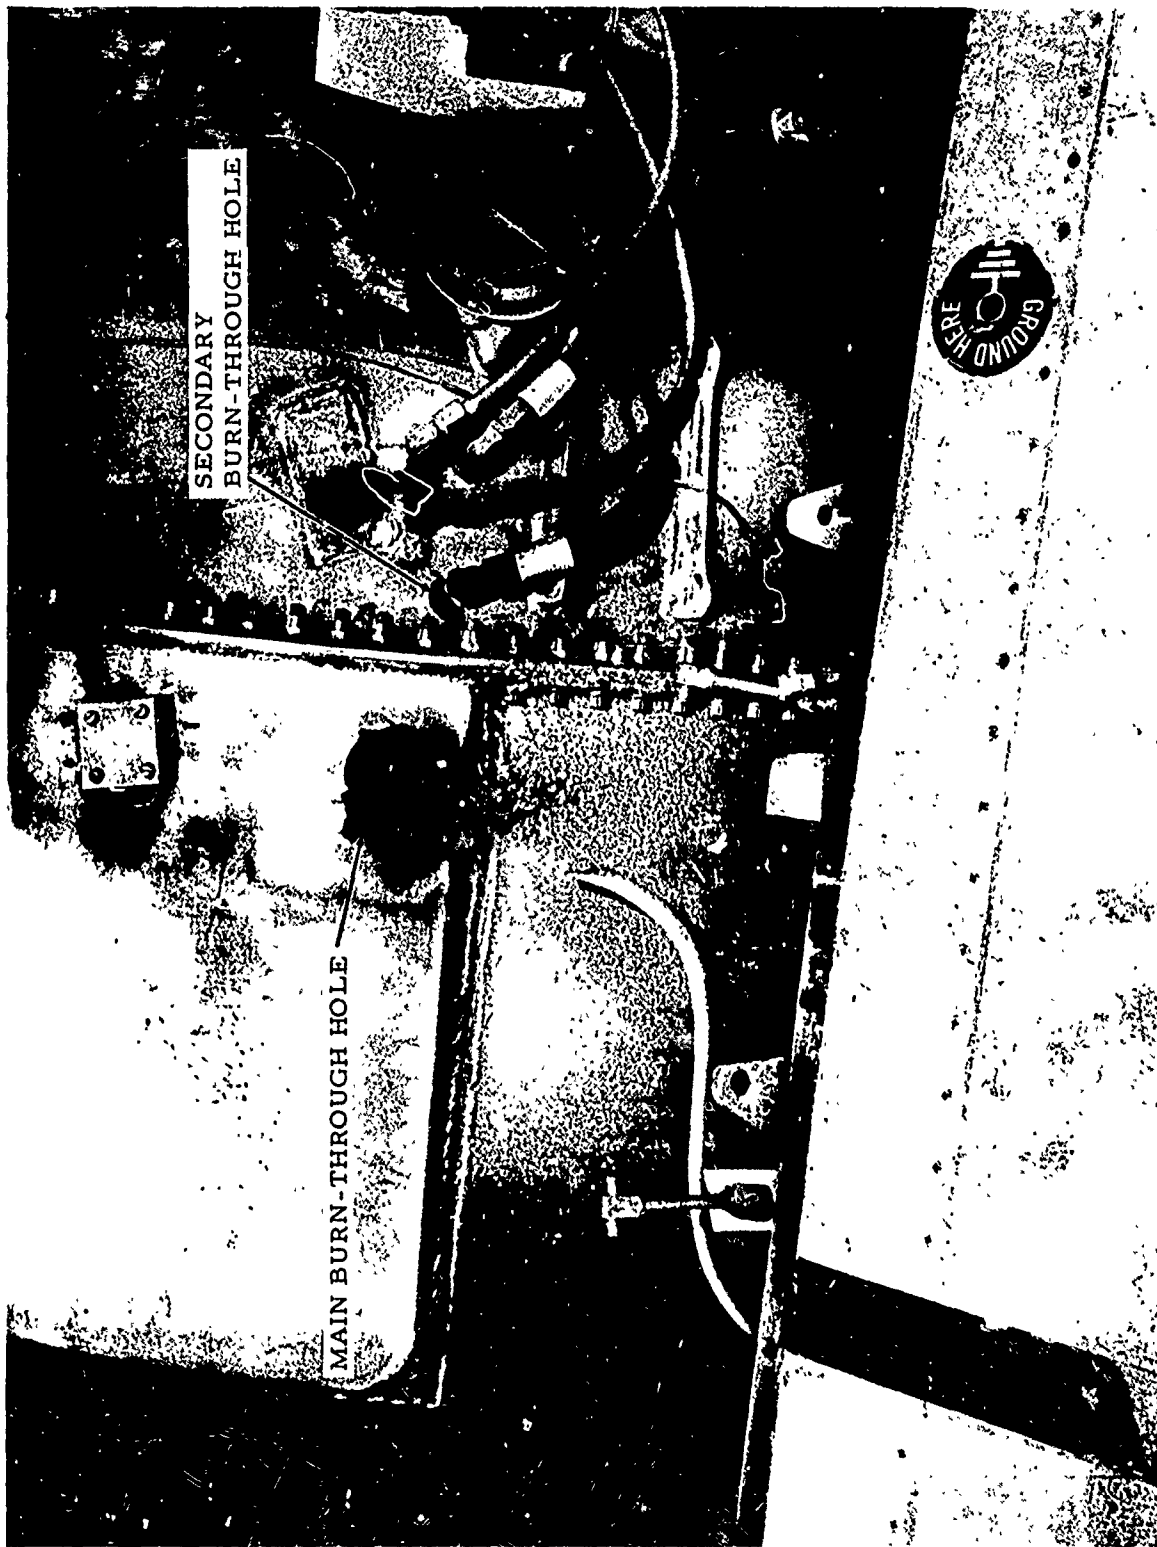
FIGURE 28. ENGINE CASE DAMAGE FROM BURN-THROUGH (TEST NO. 3)
